## TKC C-710 Nozzle Failure at 2-inch Feed Line

**IMPACT ID: #11973**

**Location: Hydro Division,  
North Isomax, TKC Unit**

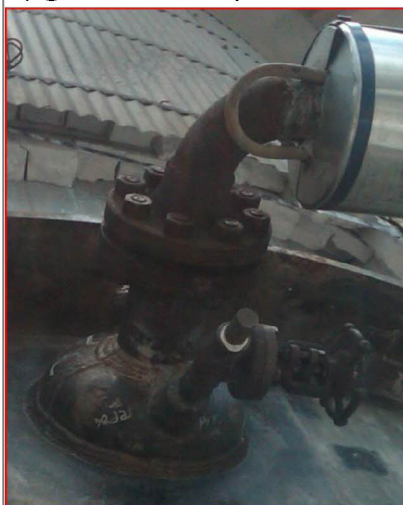
**2" feed nozzle from V-470  
(light oils at 100 F)**

The exact cause will not be confirmed until 2014 but we believe the following two items most likely caused this failure: 1) A nearby piping support was not reinstalled in 2009, thereby potentially subjecting the nozzle to excessive mechanical fatigue; and 2) possible chloride stress corrosion cracking of the weld, nozzle overlay, or vessel cladding.

- 1) Verify that the proper reinstallation of the pipe supports occurs each time they are temporarily removed for maintenance access.
- 2) Inspect the column in the vicinity of the nozzle crack during the 2014 shutdown and perform a failure analysis with ETC to make any appropriate repairs prior to startup.

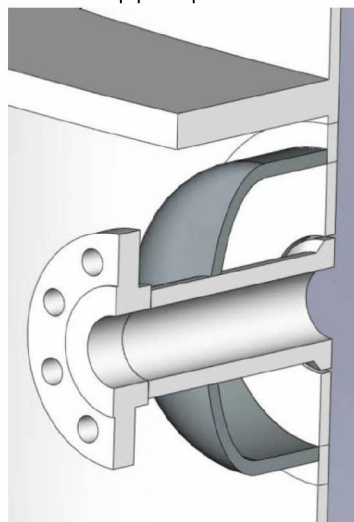
Depiction of Nozzle failure, and  
welded 8" pipe cap leak-seal
